Manhole Inspection Summary

Manhole # S06GG2003MH

Insp Date: **7/29/06 10:07 AM**

Location Address: **3506 SEVEN MILE LN**

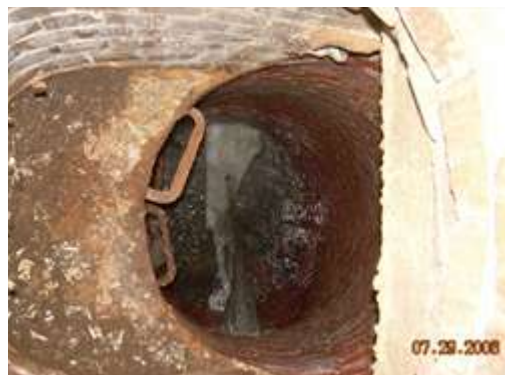
Top View

Evidence of surcharge - Bench debris.
Adjustment and Corbel infiltration.
Corroded steps.

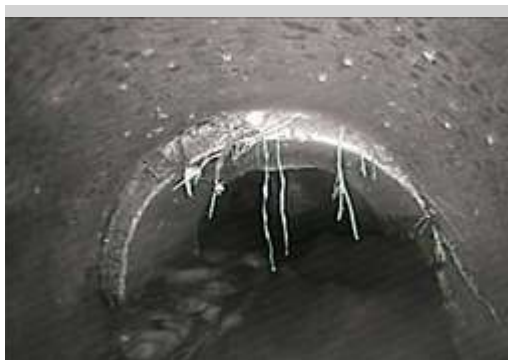
Inside of the I6

Offset joint with root intrusion.

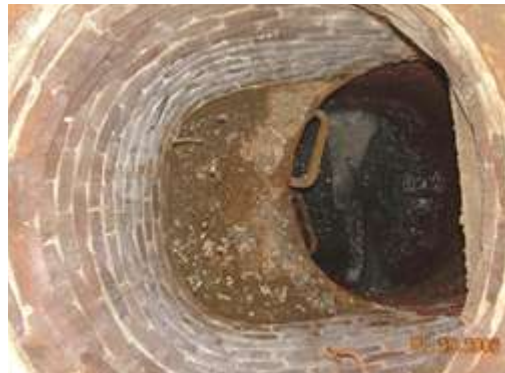
Defect

Adjustment infiltration. Corroded steps.
Corbel and Barrel offset.

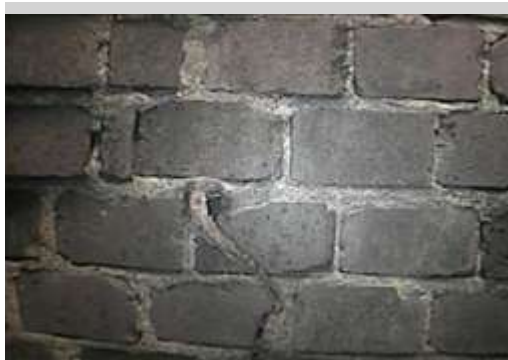
Defect

Missing step.

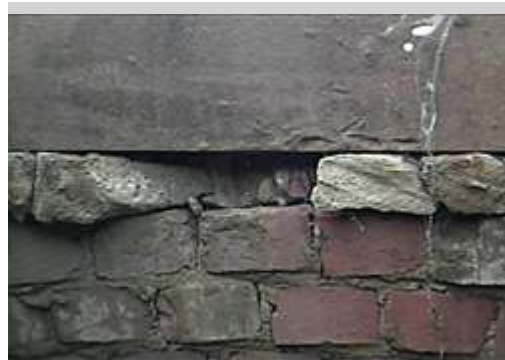
Defect

Frame leaks. Adjustment deterioration,
loose brick, and infiltration.

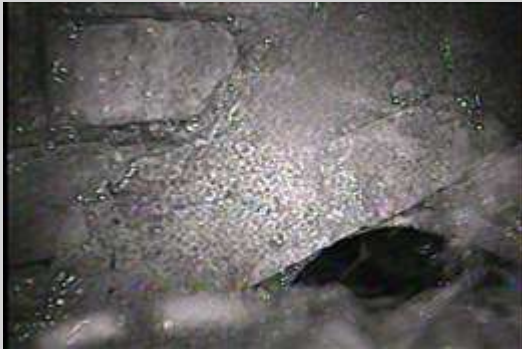
8 in. Circular Gravity Sewer Pipe Out @ 12 O'Clock

Infiltration: **Evidence** Pipe Seal Cond: **Unknown**

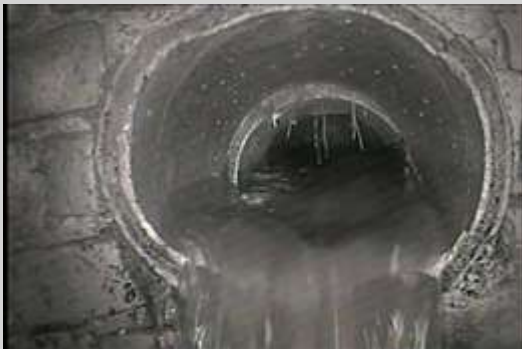
8 in. Circular Gravity Sewer Pipe In @ 6 O'Clock

Infiltration: **Evidence** Pipe Seal Cond: **Unknown**
